MISCELLANEOUS PAPER SL-79-17

TESTING OF 6-IN.-DIAMETER CONCRETE CORES FROM MARTIN DAM ALABAMA POWER COMPANY

Structures Laboratory
U. S. Army Engineer Waterways Experiment Station
P. O. Box 631, Vicksburg, Miss. 39180

August 1979

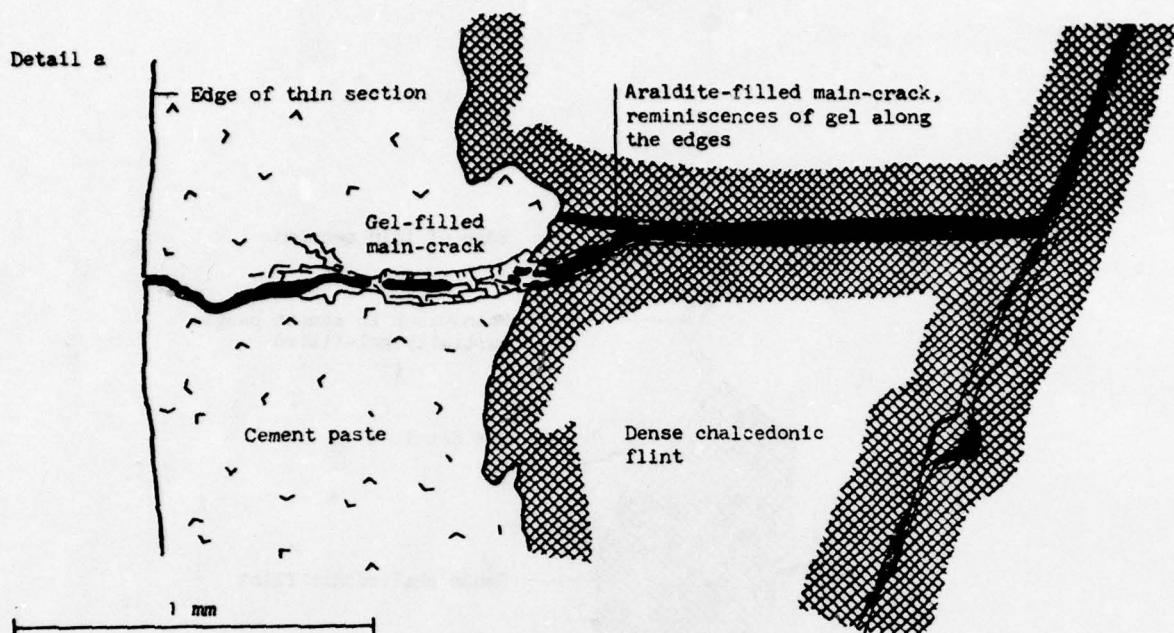
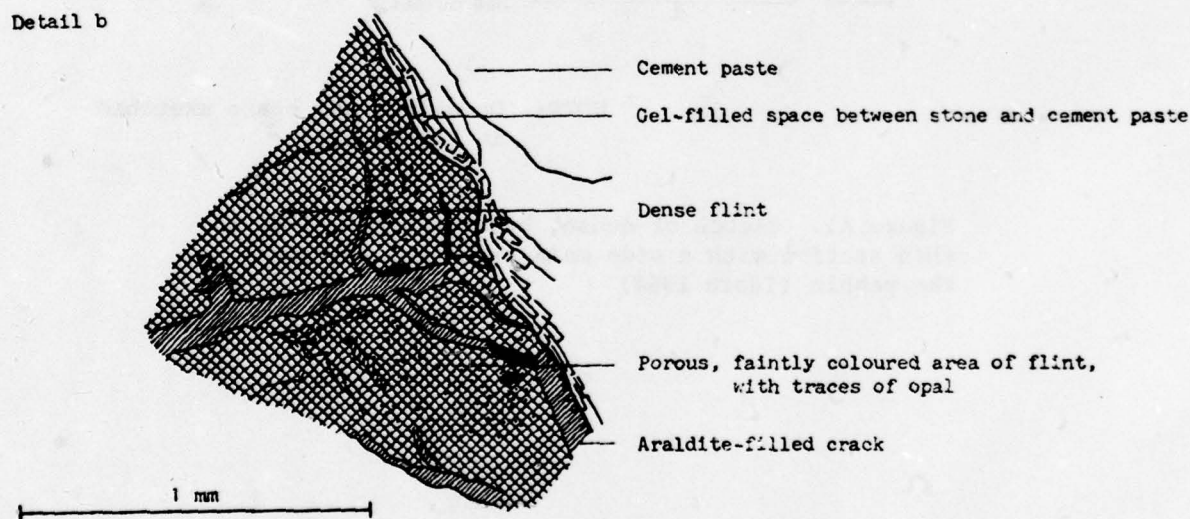
Figure A2. Details a and b of dense, heterogeneous flint. The details show the appearance of the traversing crack as it passes the edges of the particles. The difference in appearance is striking and seems to be related to the structure of the flint. (Idorn 1964)

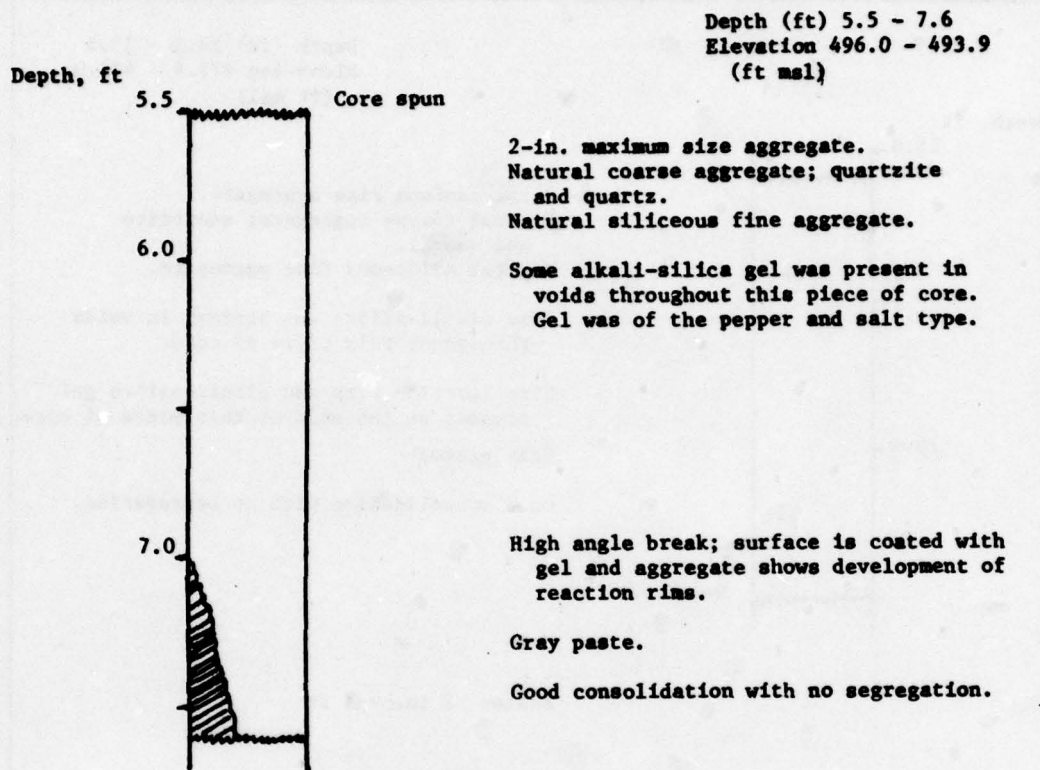
PLATE A1

a. CL-24 DC-1A through 11A (CH No. H-3). This core came from the western part of the inlet works to the powerhouse. According to the driller's log construction joints and fractures were common and the fractures suggest some movement had taken place. The concrete samples from this core hole examined in the laboratory appeared to be in good physical condition. It was well consolidated nonair-entrained concrete with some small entrapped air voids. Most of the broken ends of the pieces of core were new breaks or breaks along lift joints. The inclined break at a depth of about 7.5 ft was an old break coated with alkali-silica reaction gel. The aggregates exposed at this surface included quartz and quartzite particles with well developed reaction rims. Alkali-silica reaction gel coated a fracture surface of piece CL-24 DC-10A (Photo A1). Alkali-silica-reaction gel was detected in all of the pieces of this core that were examined. The alkali-silica gel was found in air voids lining or totally filling the void. Other alkali-silica gel was found around the aggregate particles at the paste-aggregate interface. The amount of gel was consistent throughout the core and is considered a significant amount even though only a small number of fractures were present. The majority of the paste was medium gray but

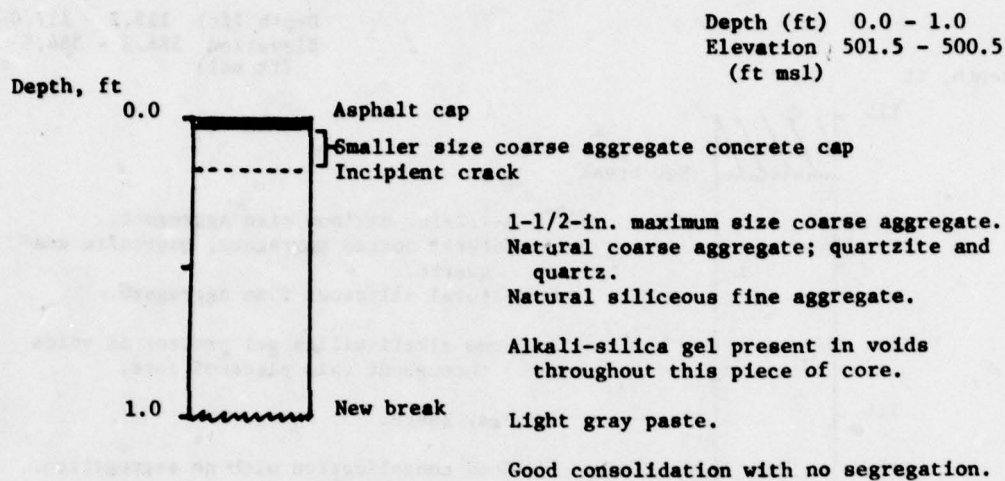
PLATE A12

b. CL-24 DC-1B through 10B (CH No. S-6). Hole S-6 was drilled in block 14 of the dam. The concrete from this hole was like the concrete from hole H-3. In addition to the alkali-silica gel, small clusters of needle-like ettringite crystals were found in the voids and other openings in the concrete. Examination of the cement paste indicated that only small amounts of ettringite were present. The relatively small amount of ettringite is considered normal.

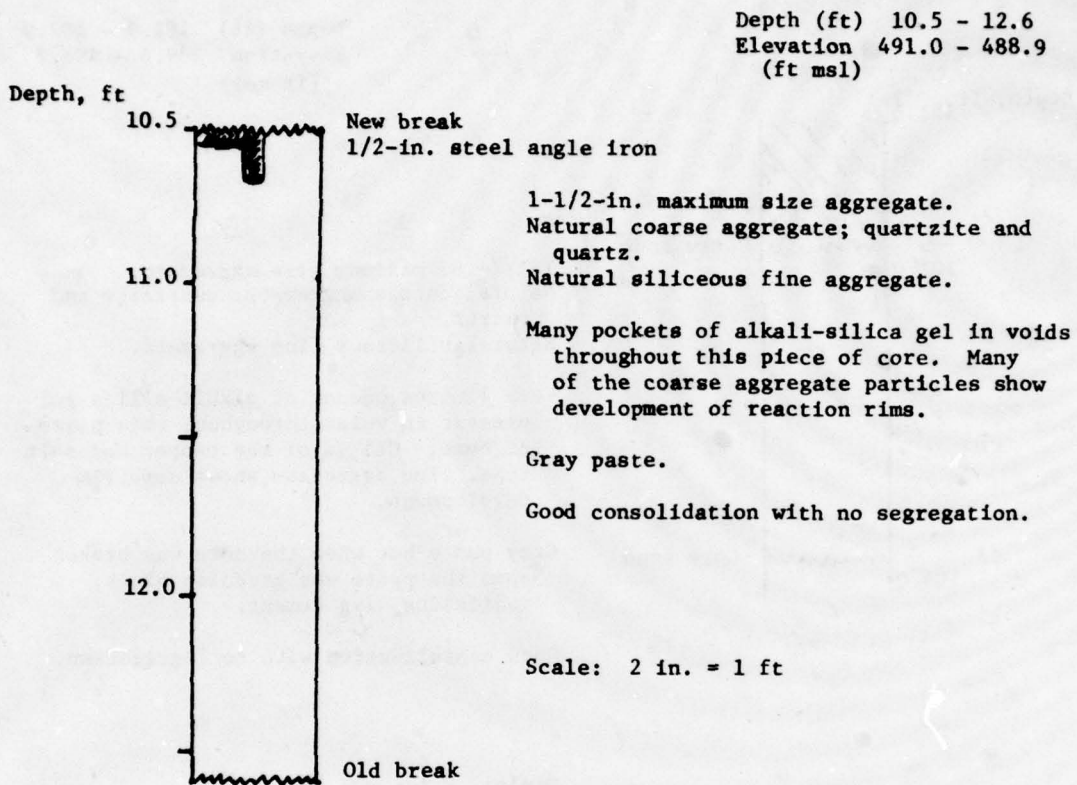
PLATE A22

c. CL-24 DC-1C through 12C (CH No. S-7). This core (S-7) came from block 3 of the dam. The concrete in this core was like that found in the other two cores. The lengths of concrete core were intact and had no outward signs of reaction except for the presence of some gel-filled voids in the upper part of the core. A broken surface which was coated with algae (Plate A26) was found at a depth of 48 ft. The surface appeared to be an open lift joint on which water flows. The amount of alkali-silica gel was less in this core than in the other two cores, and the development of ettringite was more abundant in the voids of the upper 69 ft of this core than in the two other cores examined. The deeper concrete contained very little gel, but elongated plates of tetracalcium aluminate monosulfate-12-hydrate became common in the voids. The highest concentration of these crystals was in piece CL-24 DC-7C. Scanning electron micrographs of some of these crystals are shown in Photos A3 and A4. Ettringite, $\text{Ca}_3\text{Al}_2(\text{OH})_{12}(\text{SO}_4)_3 \cdot 26\text{H}_2\text{O}$, and tetracalcium aluminate monosulfate-12-hydrate ($\text{Ca}_4\text{Al}_2(\text{OH})_{12}(\text{SO}_4)_2 \cdot 6\text{H}_2\text{O}$ or $\text{C}_4\text{A}\bar{\text{S}} \cdot \text{H}_{12}$) are both normal hydration products of portland cement. Ettringite can also be produced by the hydration of blast-furnace slag. It is common to find ettringite in the voids in concrete a few years old, sometimes in coatings and rosettes visible to the naked eye. We have not previously seen $\text{C}_4\text{A}\bar{\text{S}} \cdot \text{H}_{12}$ in flakes visible to the naked eye in voids in concrete, nor have we seen it in immersion mounts or thin sections. While its presence is not important to the stability of the concrete, this is the first instance that we know of in which $\text{C}_4\text{A}\bar{\text{S}} \cdot \text{H}_{12}$ has been seen in concrete in such large crystals. Probably a slightly lower lime content in the total cementitious material, a higher alumina content, and a lower sulfate content produced in the concrete in the lower part of this core, resulting from the presence of the 25 percent slag cement with a high alumina, low sulfate portland cement combined to favor production of $\text{C}_4\text{A}\bar{\text{S}} \cdot \text{H}_{12}$. The concrete higher in the core where ettringite was found in the voids may have contained another portland cement or may not have contained the intended proportion of slag cement.
